## CENTRAL INTELLIGENCE AGENCY

## REPORT

DATE DISTR. 24 October 1958

4. A sketch of the city plan of Ch'ongjin.

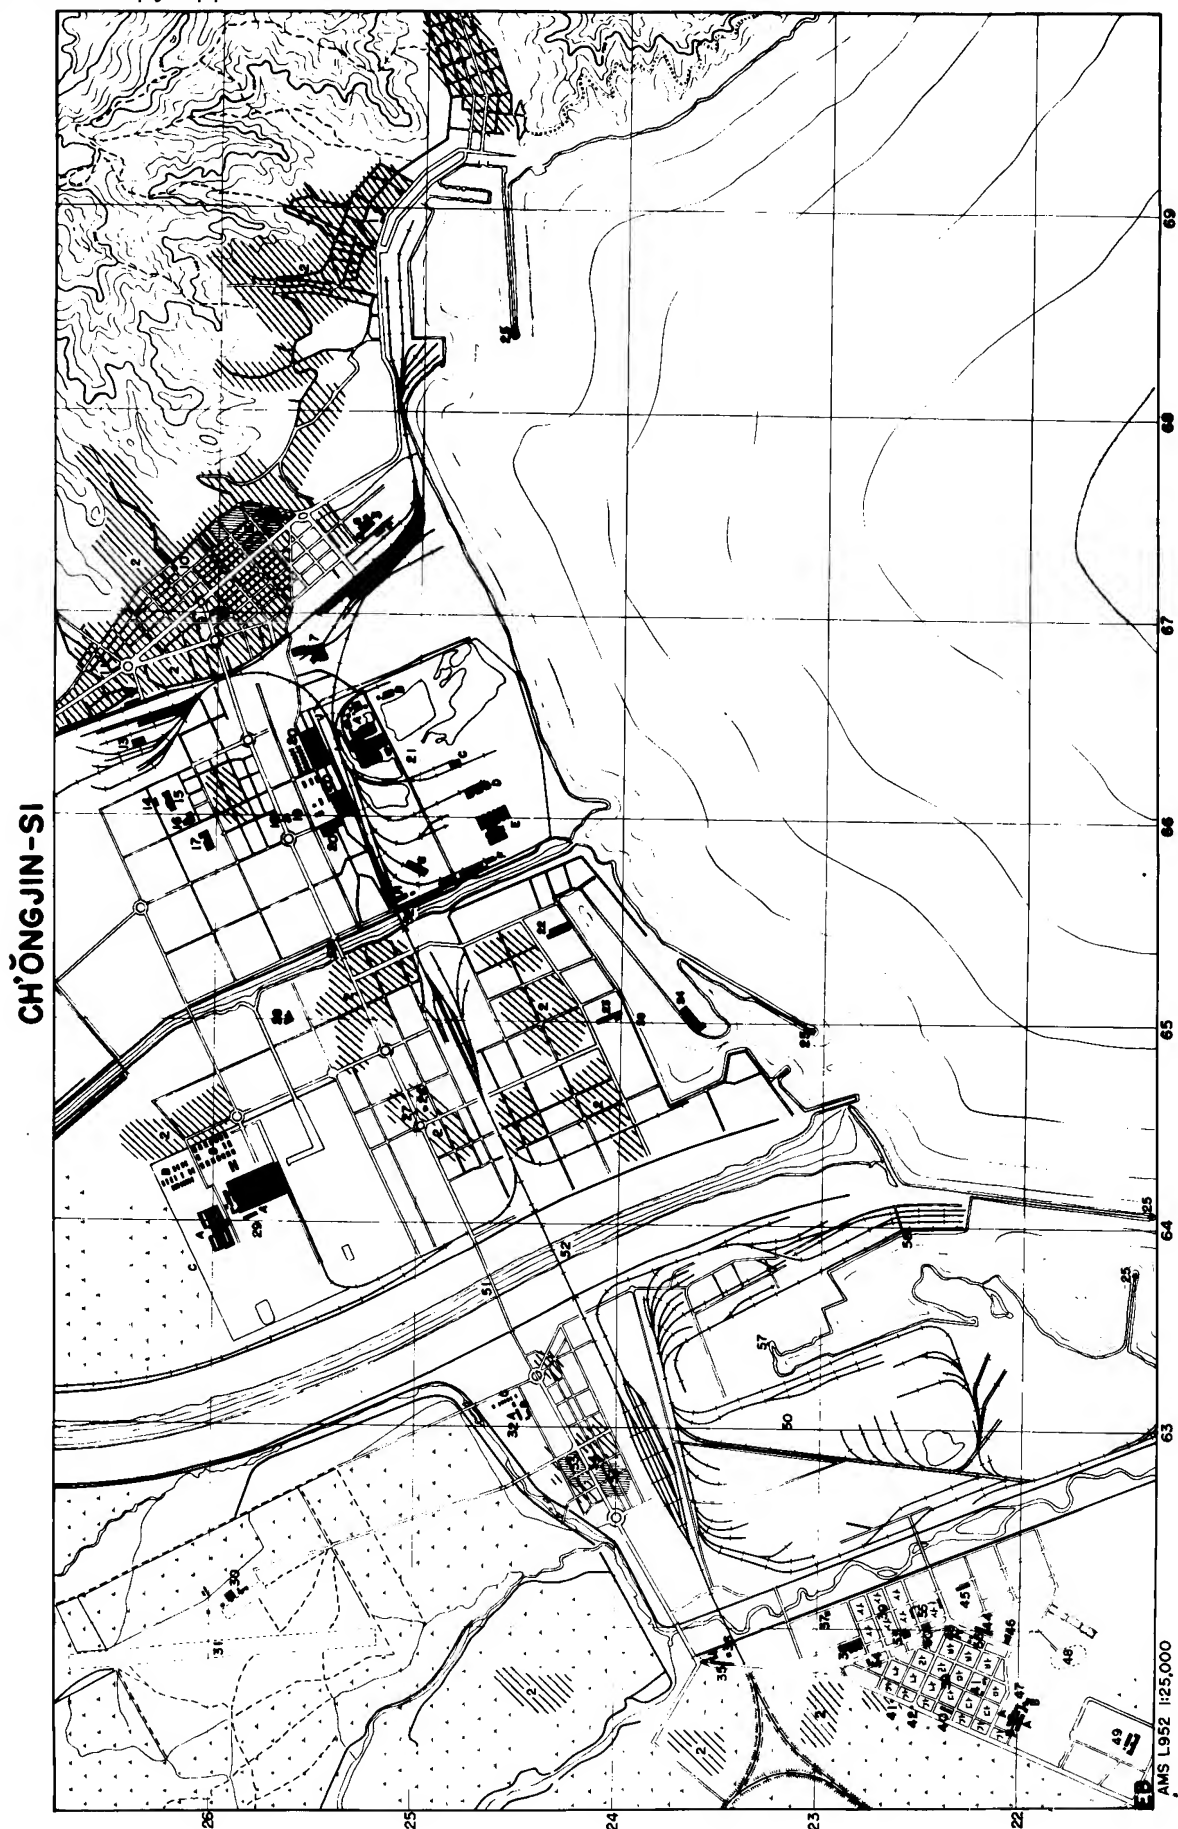
1. Ch'ongjin Branch of the Central Bank of North Korea, a stone structure with a tin-plate roof, approximately 13 meters high, 30 meters long, 25 meters wide, damaged during the war and repaired following the armistice. During the Japanese occupation the building was occupied by a branch of the Korean Bank.

2. Residential Areas, indicated by oblique lines.
3. Ch'ongjin Machine Factory, a Grade IV enterprise which employed approximately 100 workers, occupied two buildings: Building A, "L"-shaped, was single-storied with brick walls, a tin-plate roof; approximately 40 meters long on one side, 20 meters long on the other and 13 meters wide. Building B was single-storied with brick walls, a tin-plate roof; approximately 40 meters long and 13 meters wide. Both buildings were damaged during the war but were repaired after the armistice. The factory produced parts for lathes, mining machines and ship engines.

4. Ch'ongjin Railroad Freight Office, damaged during the war but repaired after the armistice, had continuously occupied the same site since the Japanese occupation. The office handled rail shipping for North Korean organizations but not for individual citizens.

5. Bus Station and National Department Store. In front of the department store near the market, this bus station was called the "Front of Market" station. The national department store was a two-story structure with brick walls, a cement tile roof, approximately 9m x 20m x 13m. On the first floor ~~were~~ <sup>sections for food, tobacco and consumer supplies</sup> and on the second floor, <sup>clothing, shoe and drug sections</sup>. ~~After being destroyed by bombs during the war, the store was reconstructed after the armistice.~~

6. Ch'ongjin Market, indicated on the sketch with crisscrossed lines.
7. Roundhouse, damaged during the war but reconstructed after the armistice.
8. Ch'ongjin-si People's Committee Building, three-storied with cement walls and a cement tile roof; approximately 16m x 30m x 18m. This building was built in mid-1946 and was only slightly damaged during the war.

12. Ch'ongjin Railroad Station, a two-storied structure with brick walls painted black, a cement tile roof; approximately 10m x 30m x 15m; bombed during the war and rehabilitated following the armistice.

13. Ch'ongjin Railroad Factory, which repaired locomotives, was framed in girders, had brick walls painted black and was approximately 10m x 50m x 25m. The building was constructed by the Japanese, ~~damaged during the war, and rehabilitated after the armistice.~~

21. Ch'ongjin Steel Mill, which produced steel under Japanese management, had, after war damages were repaired, begun the manufacture of granulated iron products by melting pulverized iron ore. The mill's production, which averaged about 200 tons per day, was shipped by rail to the Songjin Steel Mill where it was charged, along with manganese, molybdenite and tungsten, into an electric furnace for the production of steel. Buildings within the compound indicated on the sketch were as follows:

A. Fire-brick factory B. Transformer station C. Transformer station	D. Warehouse E. Blast furnace F. Warehouse
---	--

- G. Electric furnace plant, installed by the Japanese
- H. Locomotive shed
- I. Railroad track
- J. Board fence surrounding the compound

22. Ch'ongjin Shipyard, a red brick building with a cement roof; approximately 10m x 50m x 30m. Engaged in the production of engines and parts for boats, the shipyard's capacity was greater in June 1956 than it had been under the Japanese. 25X1 it produced 10 boats a month. Approximately 400 workers, including personnel from the Shipbuilding Department, were employed at the yard.

24. Shipbuilding Department, Ch'ongjin Shipyard, a red brick structure with a slate roof; 8m x 50m x 30m; reconstructed after the armistice. In June 1956 it was producing 40 or 50-ton powered boats.

50. Kimch'aek Iron Works
51. Songp'yong Bridge, spanning the Susong River, was bombed during the Korean War and reconstructed according to its original design after the armistice. The height of the bridge from water level was approximately 10 meters; the depth of the river was 2 meters.
